Your Inspection Report

443 Madison
Toronto, ON

INSPECTION DATE:
Saturday, June 21, 2014

RE: Report No. 1366, v.33
443 Madison
Toronto, ON

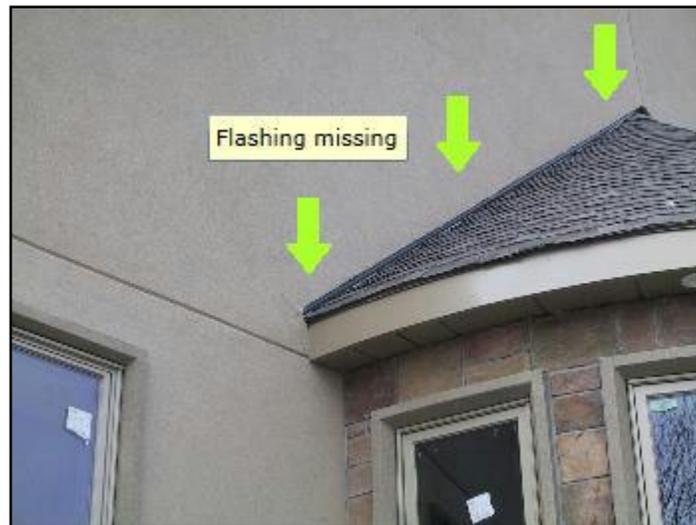
4. **Condition:** • [No kickout flashing](#)

1. No kickout flashing at roof/sidewall junction

Task: Improve

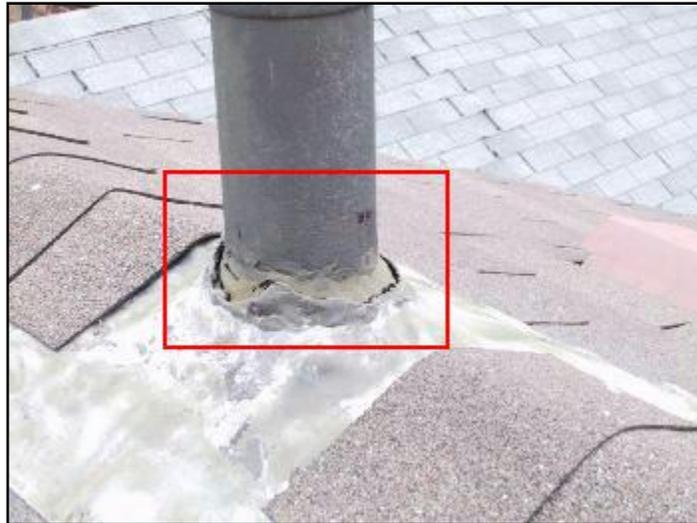
5. Condition: • [Leak](#)

2. Stack flashing should be sealed.

Task: Repair

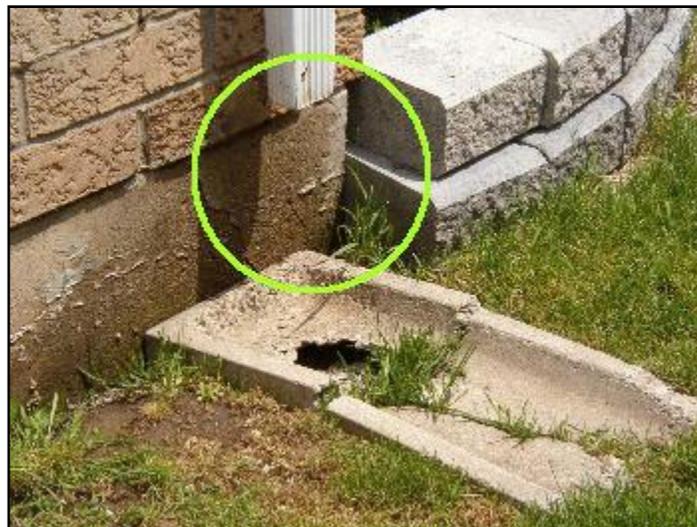
7. Condition: • [Downspouts end too close to building](#)

3. Downspout should be extended away from home

The downspout should be extended to discharge at least 6 feet from the home. The broken splash block can be discarded.

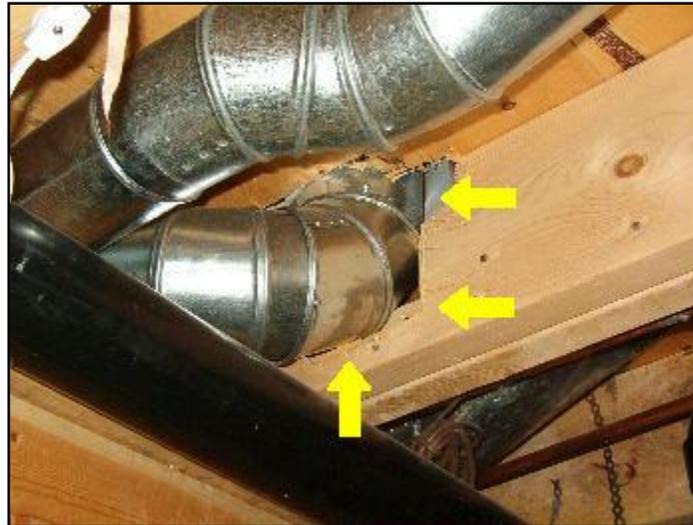
8. Condition: • [Notches or holes](#)

4. Double joist cut for ductwork

Task: Repair

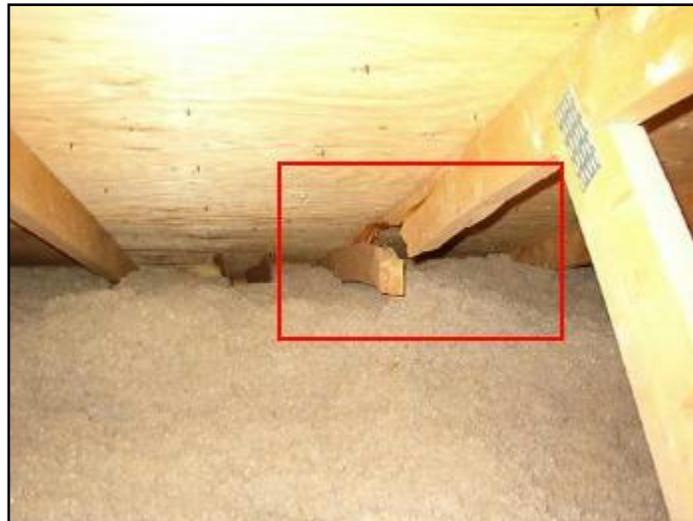
9. Condition: • [Split](#)

5. Top chord of truss is broken

Task: Repair or replace

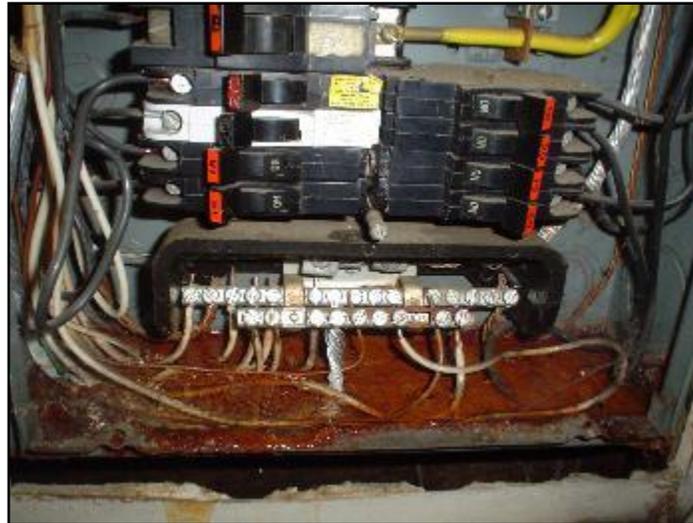
11. Condition: • [Rust or water in panel](#)

6. Water and rust in bottom of panel

Task: Replace

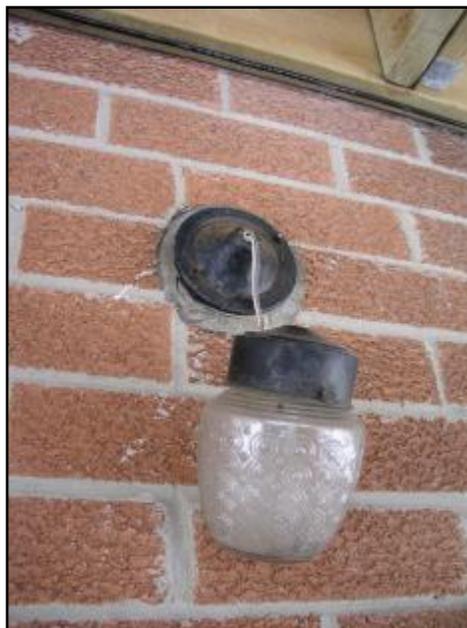
13. Condition: • [Loose](#)

7. Light fixture is not well secured

Task: Repair or replace

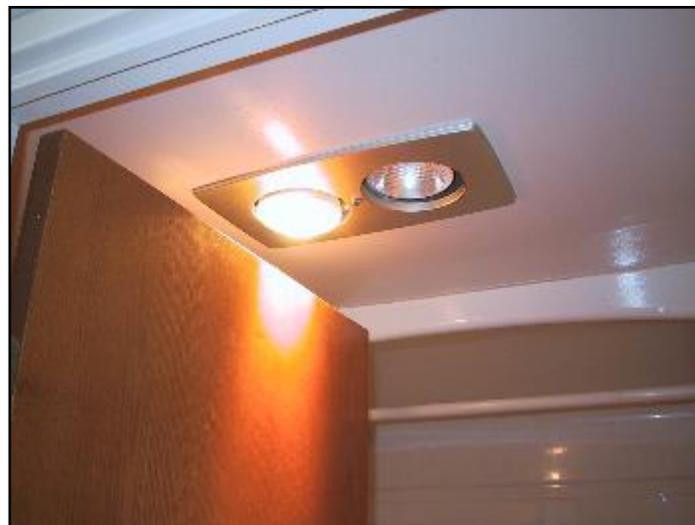
14. Condition: • [Heat lamps over doors](#)

8. Heat lamp over door - fire hazard!

Task: Correct

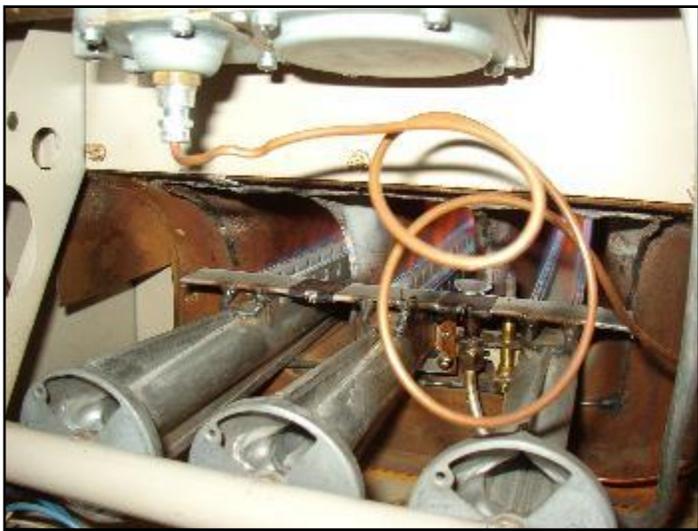
9. Rust at bottom of heat exchanger

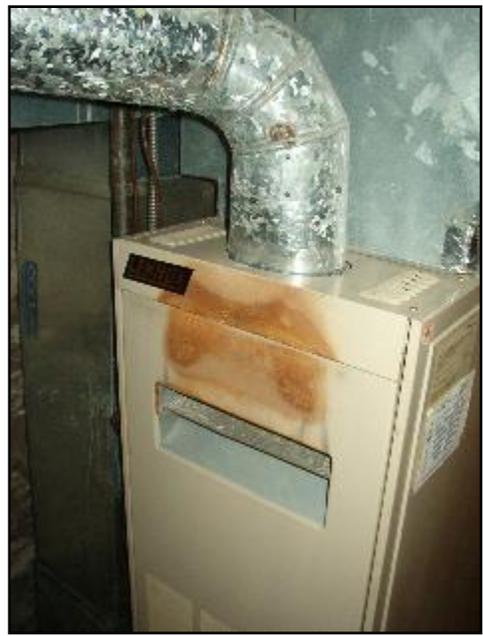
17. Condition: • [Draft hood spillage or backdraft](#)

A considerable amount of rust was noted on the front of the furnace.

This suggests a back-drafting problem, with combustion products entering the home.

This is a safety issue that should be addressed without delay.

10. Evidence of furnace backdrafting

Task: Correct

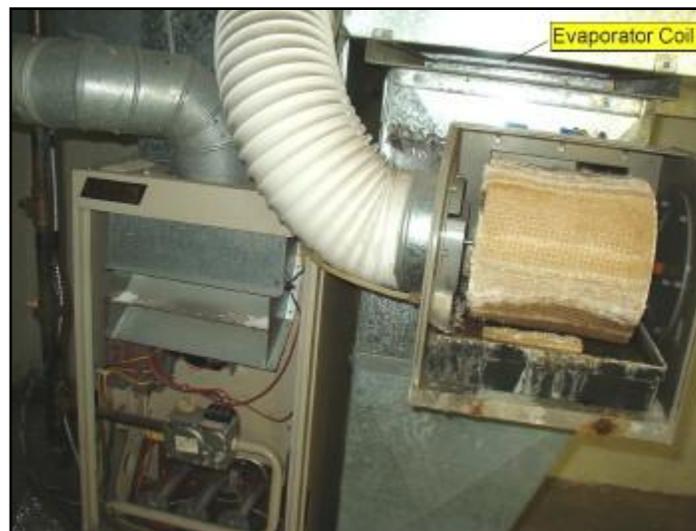
18. Condition: • [Leak](#)

11. Leaking and inoperative humidifier

Task: Repair or replace

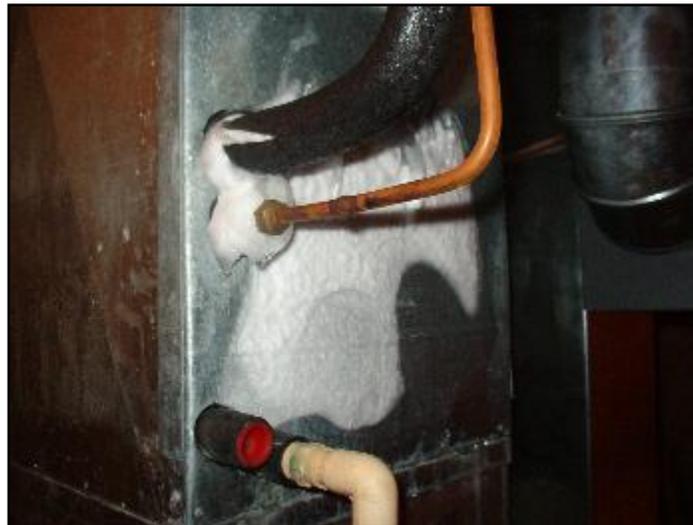
19. Condition: • [Frost](#)

12. Frost visible on ductwork at AC coil

Task: Repair

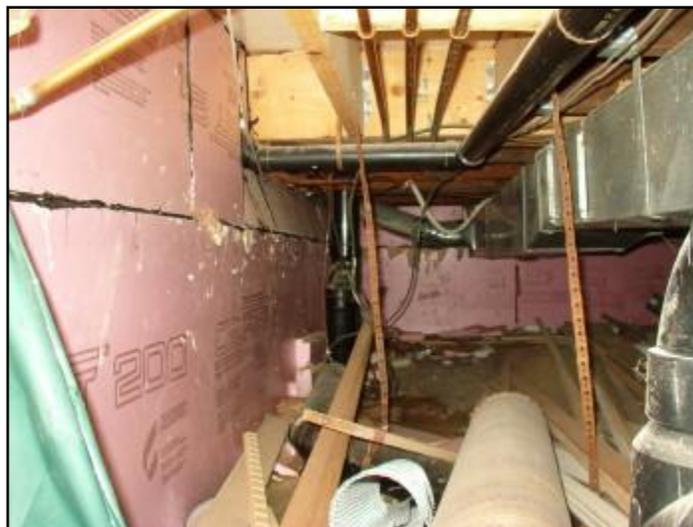
20. Condition: • [Exposed combustible insulation](#)

13. Exposed polystyrene insulation is fire hazard

Task: Remove or cover with drywall

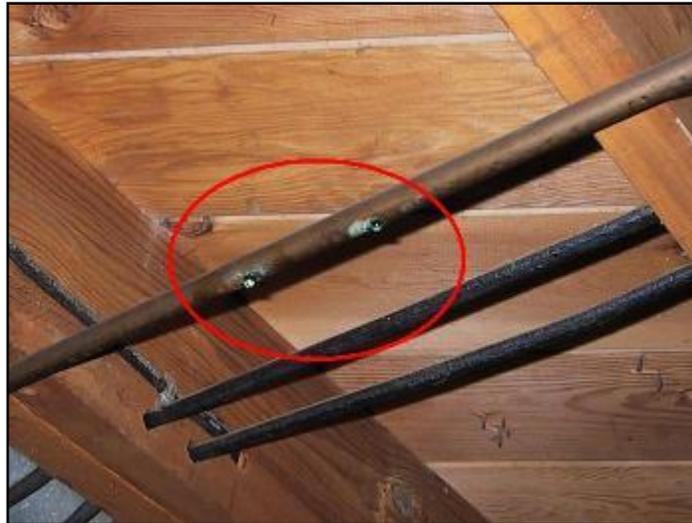
21. Condition: • [Leak](#)

14. Leaking copper supply pipe

Task: Repair

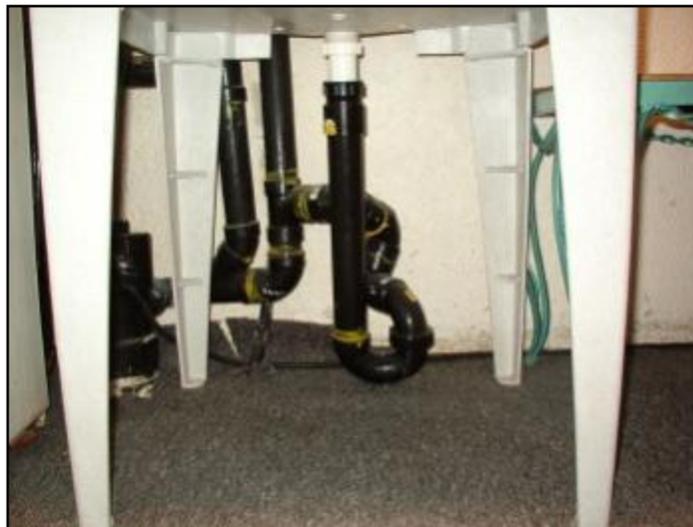
22. Condition: • [Nonstandard shape or material](#)

15. Poor trap arrangement

Task: Improve

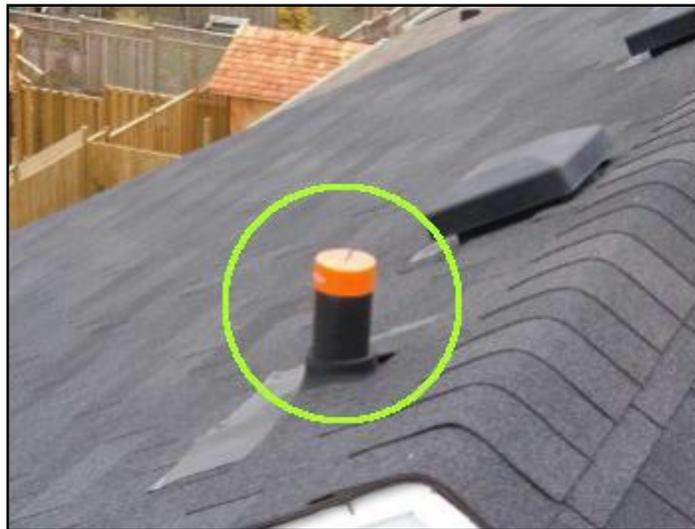
23. Condition: • [Vent termination problems](#)

16. Plumbing stack is capped

Task: Remove cap

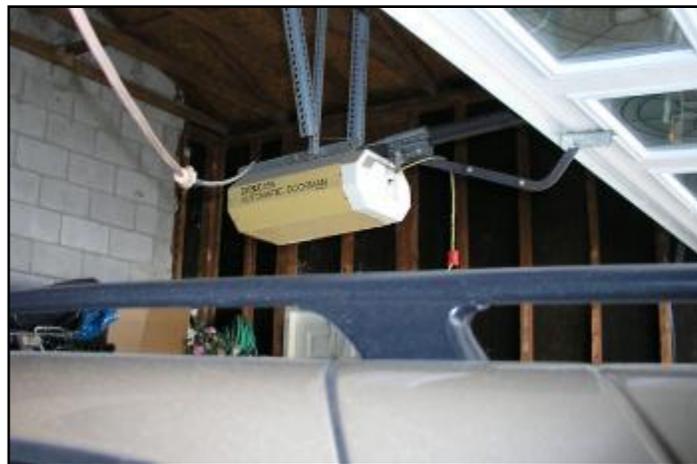
25. Condition: • [Extension cord for opener](#)

17. Extension cord for west garage door opener

Task: Replace with permanent wiring
